**Australian Forestry Management Pty Limited (AFM)**

**2005 Softwood Project**

**2012-2013 Annual Report**

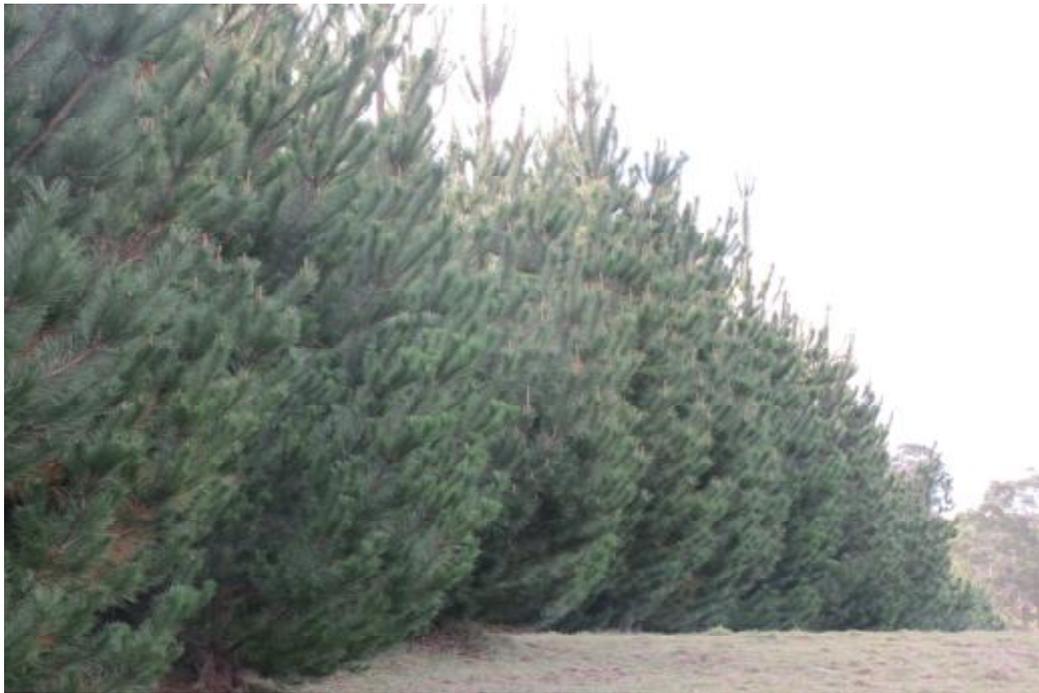
The plantation has grown noticeably since last year despite the poor growing season. Form is good and weeds, as noted last year, are no longer a serious source of competition.

Isolated heavy grazing by kangaroos and wallabies remains an issue.

**Figure 2: Mingary Vale 2006 AC – Good growth and vigour (June 2013)**

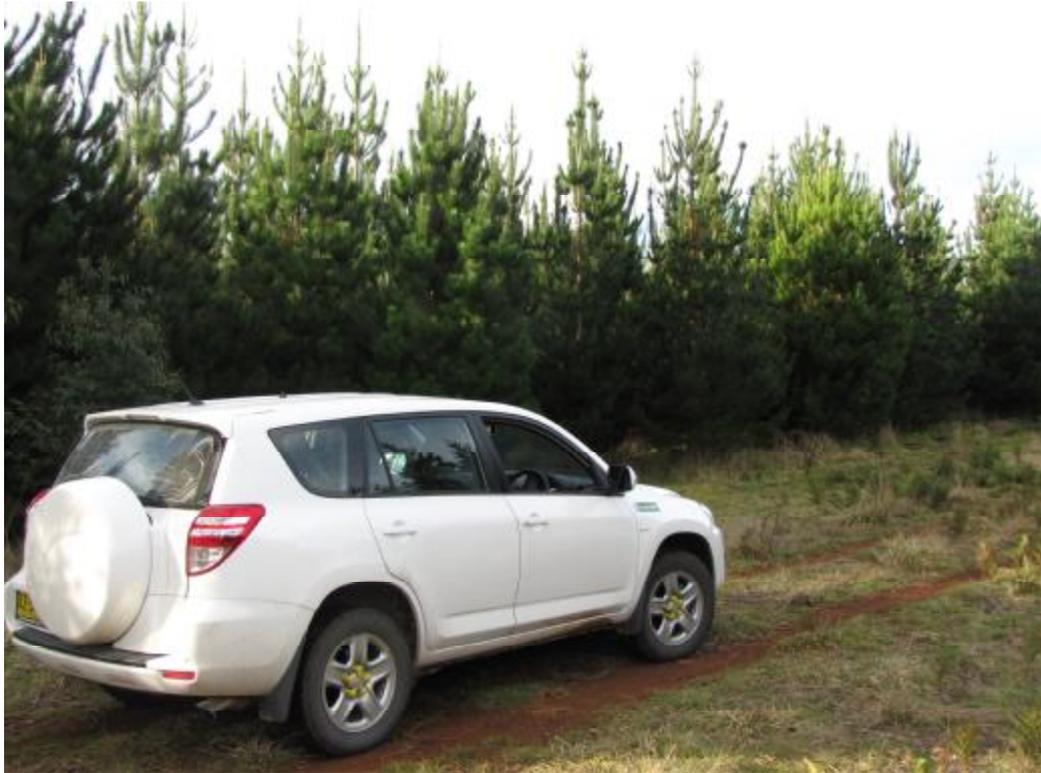
**Figure 3: Mingary Vale – excellent access for forest management and protection activities (June 2013)**

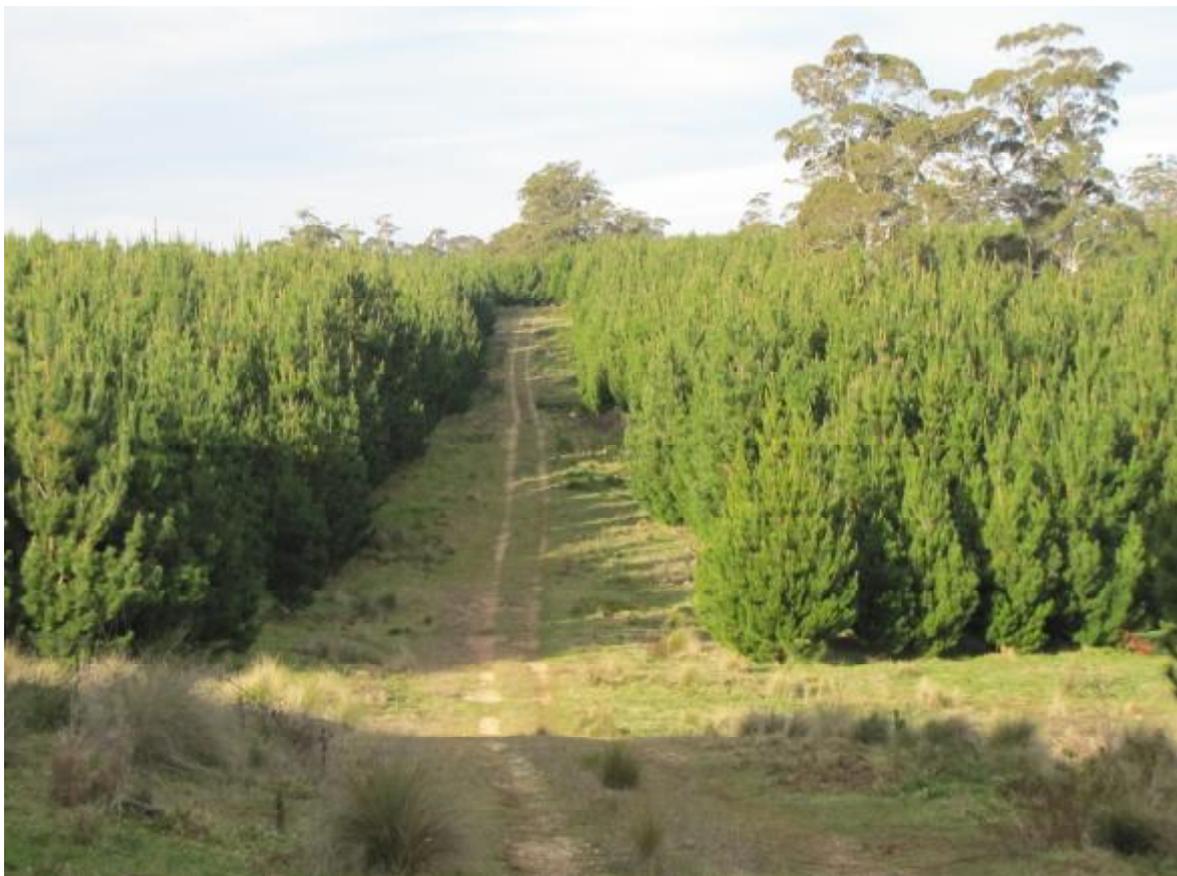
**Figure 4: Mingary Vale – exhibiting good growth and form**

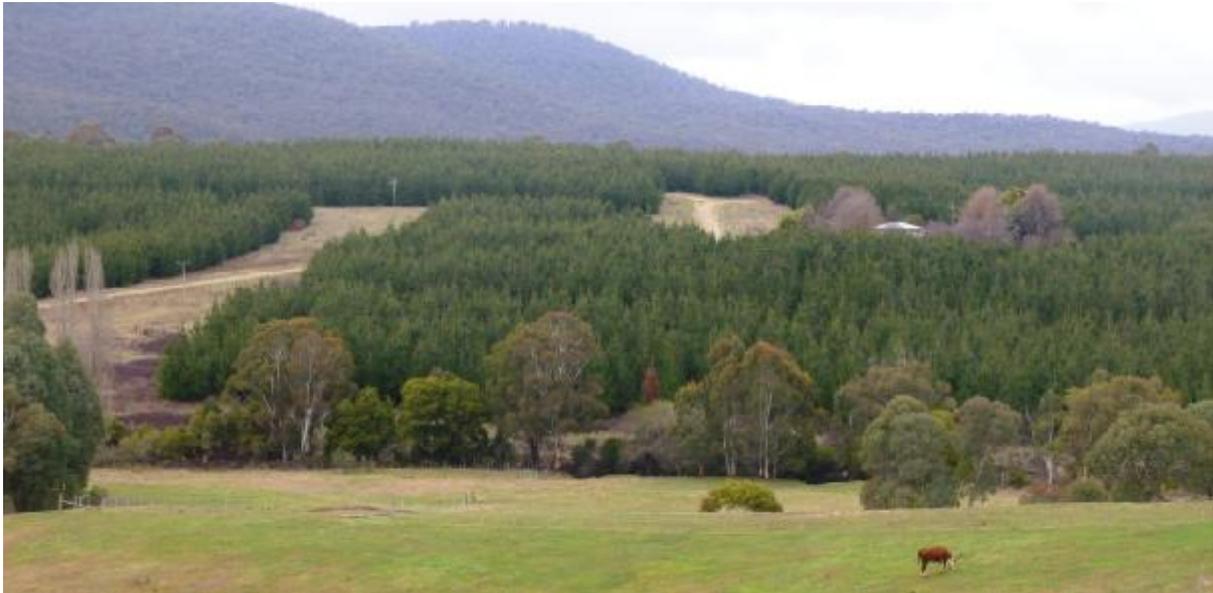
Satisfactory stocking, very good condition and growth. This plantation continues to perform well.

**Figure 5: Maragle Park – very good condition and growth**

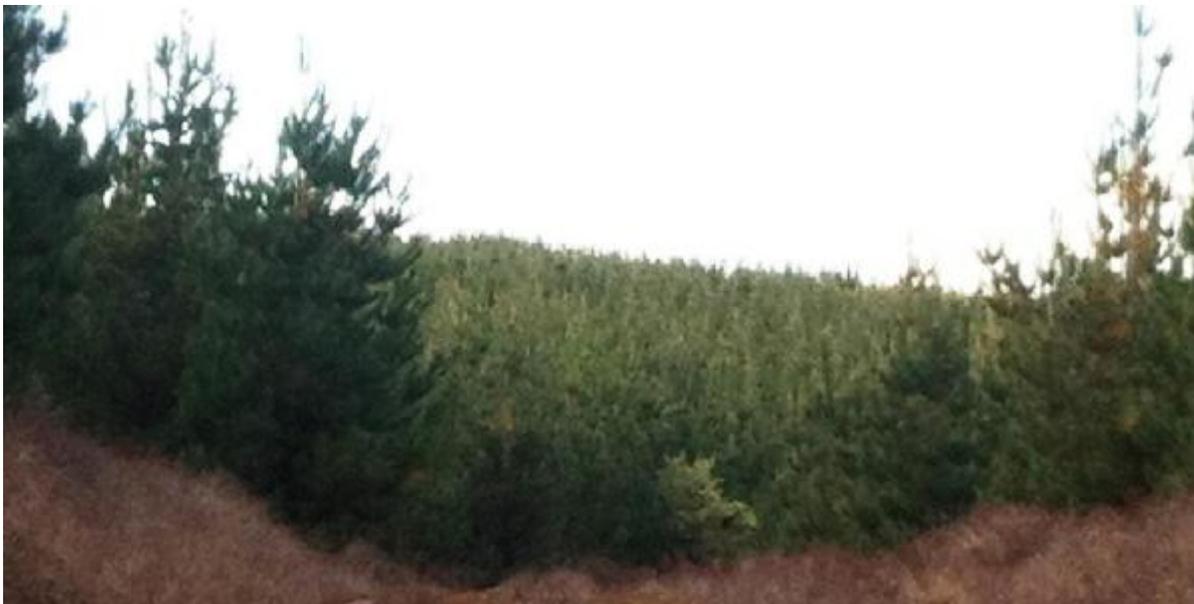
Good stocking and growth. Small patches of heavy wattle regrowth will be reviewed for treatment.

**Figure 6: Paddy's River (in background) – July 2013**

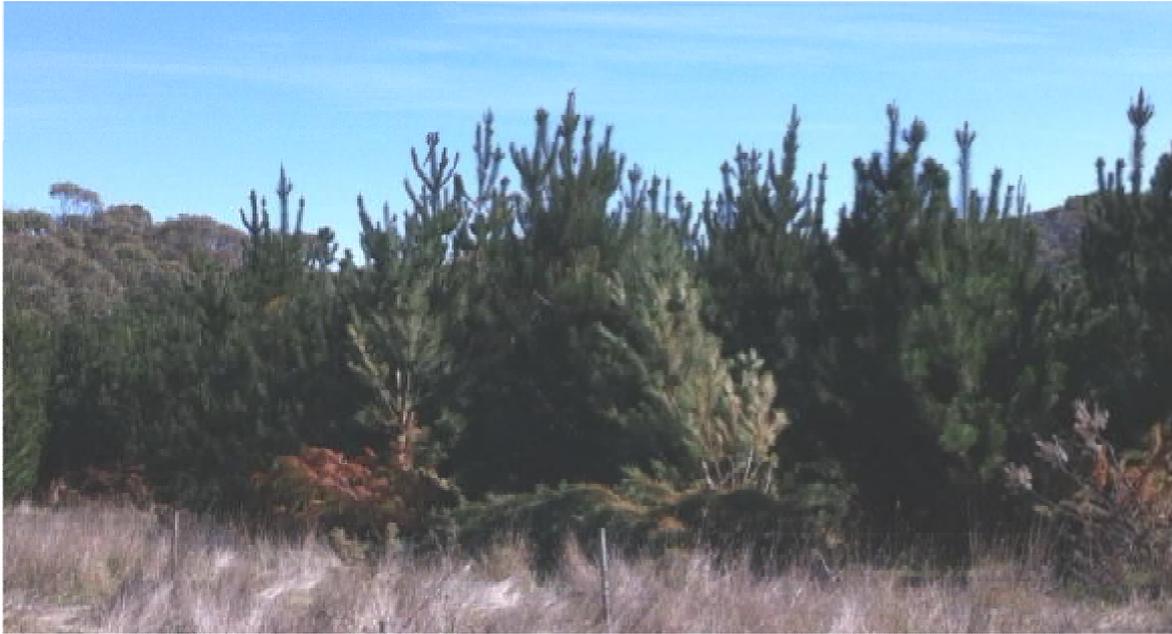
Condition and growth at Parkers remains variable. As reported in March 2013, toppling of individual trees, predominantly around the edges of the plantation, has occurred. This damage is thought to have been precipitated by a period of very strong easterly winds in February 2013. Across the plantation, the incident rate is very low and generally affected trees with poor root development.

Low levels of Dothistroma needle blight infection is present in the low lying areas.

**Figure 7: Parkers 2006 AC May 2013 – Good tree growth and ‘toppling’ on plantation edge.**

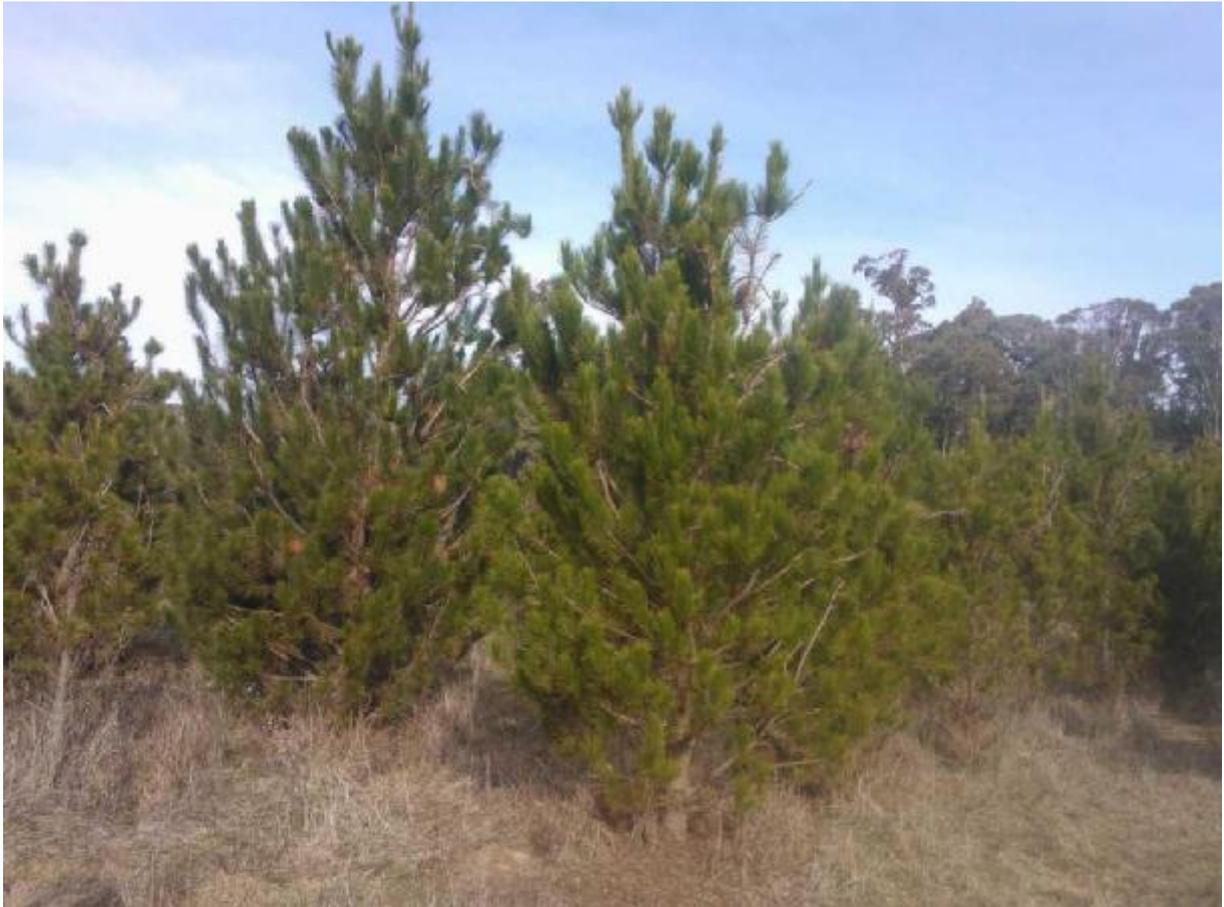
As previously reported, stocking in this plantation is mostly adequate but variable, estimated to range from 600 to 800 stems per hectare. Replanting over the last couple of years has improved the stocking in some of the previously poorly stocked areas, however on rocky and cold air drainage sites the survival of replanted trees has been low.

An area estimated to be 25 hectares has stocking levels that are very low, despite significant replanting efforts. Generally, growth on this site has been slow and affected by the past drought conditions, feral animal grazing and the cold temperatures experienced at the site.

As previously reported, sections of the plantation were subject to a hail storm in late 2011. The condition of trees affected by this event has generally improved however an area of around 21 hectares remains badly affected. Within this area there are trees with substantial damage to their main stem and dead topping has led to some major stem growth deformities. Both of these conditions will impact on future log quality and value, particularly as the area has a below average stocking.

**Figure 8: Ruby Creek - Tree growth affected by hail damage and site conditions July 2013**

- Mapping of understocked areas, Ruby Creek
- Maintenance of roads and tracks
- Fire risk reduction works and surveillance
- Grazing where fencing is available and it is assessed that there will be minimal tree damage, particularly Mingary Vale, Parkers and Vans.
- Identification and signage of plantation fire roads to comply with Plantations and Afforestation Code amendments

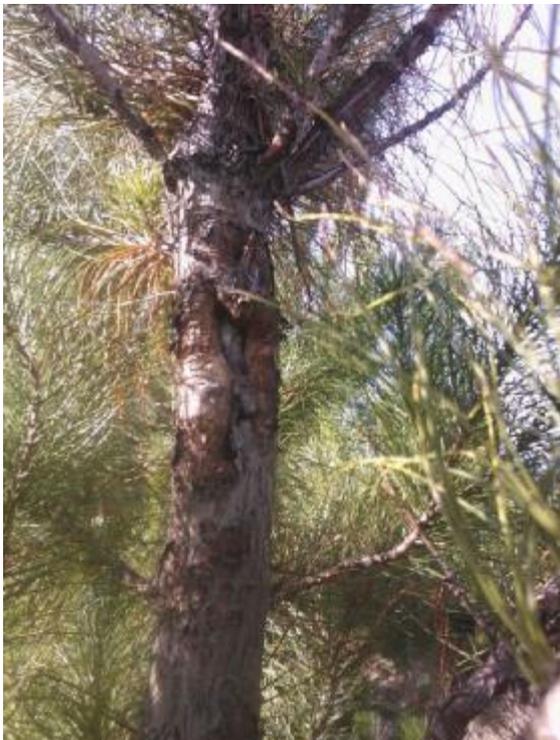
**Figure 9: Example of tree severely affected by hail damage**

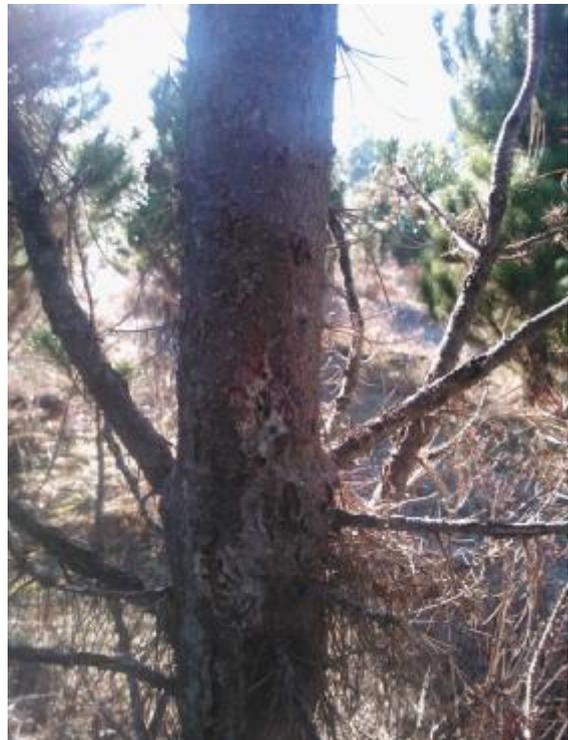
**Figure 10: Example of Tree moderately affected by hail damage with acceptable recovery**

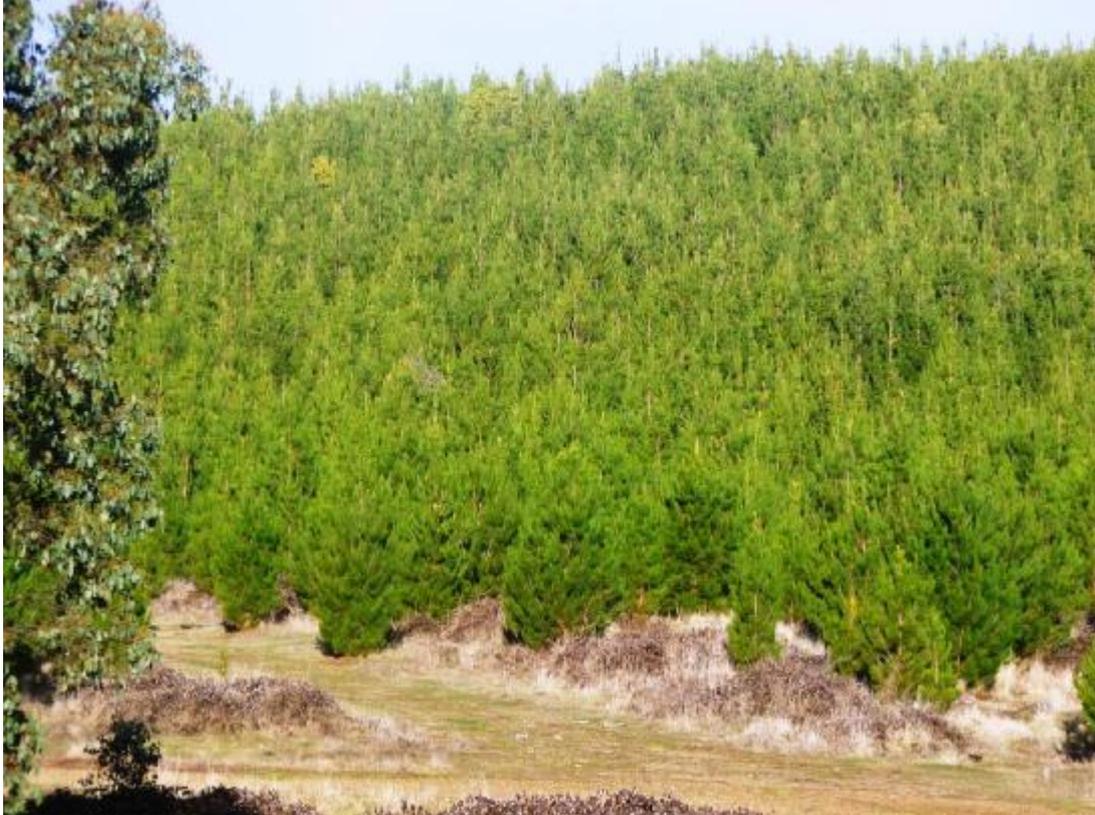
The Valley plantation remains predominantly well stocked with acceptable tree growth. As previously reported, there are localised areas surrounding drainage lines which are unstocked, or have low stocking due to poor drainage and severe frost. Previously reported browse damage within Compartment 2007 has reduced stocking to low levels. These areas were assessed and rejected for restocking on the basis that they were associated with wet or rocky ground that is problematic for successful plantation establishment.

**Figure 11: The Valley 2006 AC- Well stocked (background) and localised unstocked (foreground) plantation . July 2013**

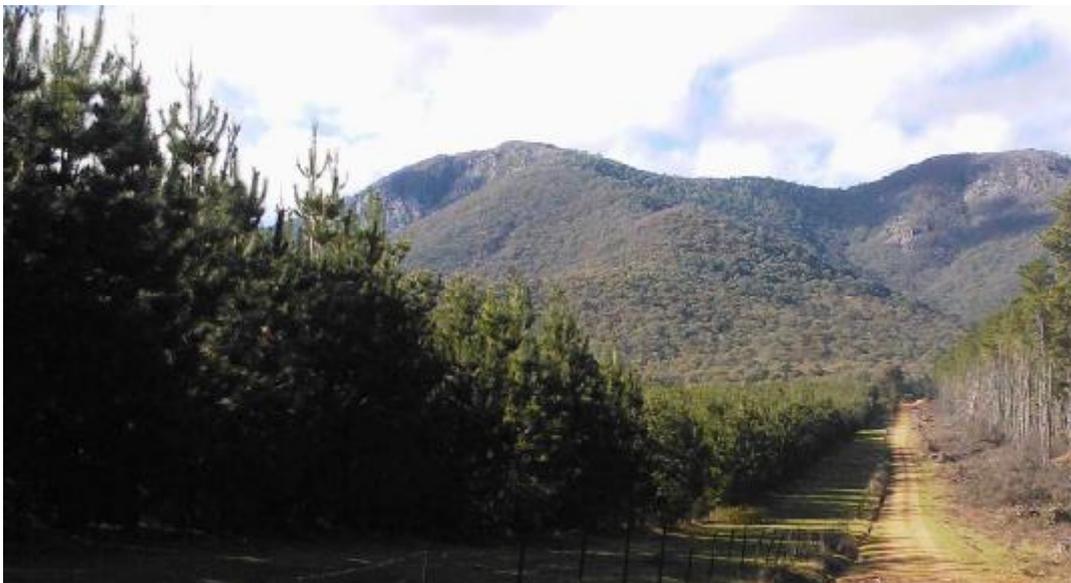
The Vans plantation continues to perform very well. The health of trees, affected during 2012 by *Dothistroma* needle blight infection, has significantly improved.

**Figure 12: Vans plantation – very good health and growth July 2013**

In late 2012 an aerial application of copper based fungicide was considered for treatment of plantations infected with Dothistroma. The weather and seasonal forecast at the time indicated that climatic conditions were not conducive to ongoing infection and a decision was made to not treat. Hot and dry weather conditions were subsequently experienced in the first half of 2013 and this has significantly reduced the level of Dothistroma activity, particularly in the Van's plantation.
