**Australian Forestry Management Pty Limited (AFM)**

**2005 Softwood Project**

**2012-2013 Annual Report**

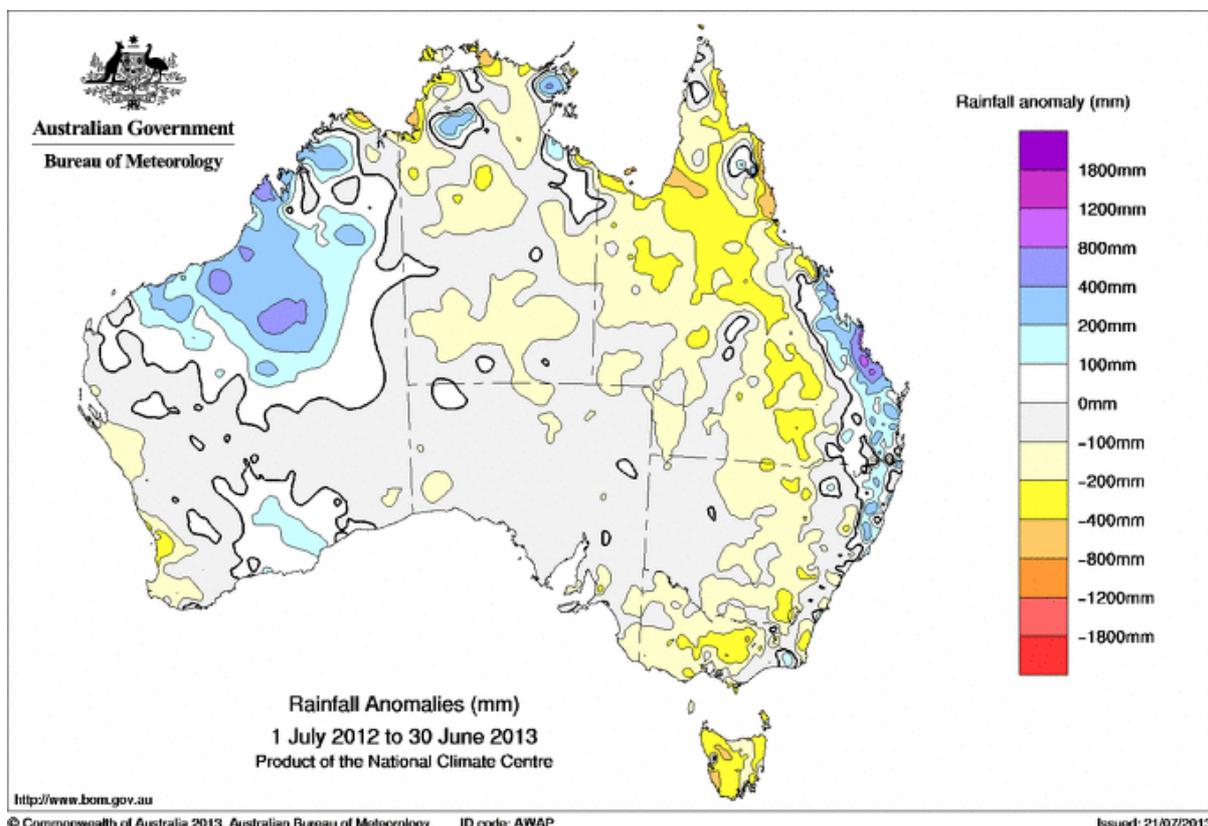
Rainfall in both the Hume and Macquarie Regions was below average, with significant dry periods during summer and autumn. Total rainfall at Tumbarumba from July 2012 to June 2013 was 831 mm compared to the long term average of 980mm, and rainfall for Yass being approximately 500mm, compared to a long term average of 584mm. Rainfall in the Macquarie Region was 531mm versus the long term average of 638mm (refer Appendix 1). Unfortunately below average rainfall occurred in the critical spring/early summer growing period from September through to December 2012 (Average: 235mm Actual: 75mm).

Figure 1: NSW Rainfall Anomalies (mm) 1 July 2012- 30 June 2013
